## 5.0 Progress Since Last Review

*Third Five-Year Review Report, Stringfellow Superfund Site, Riverside County, California*

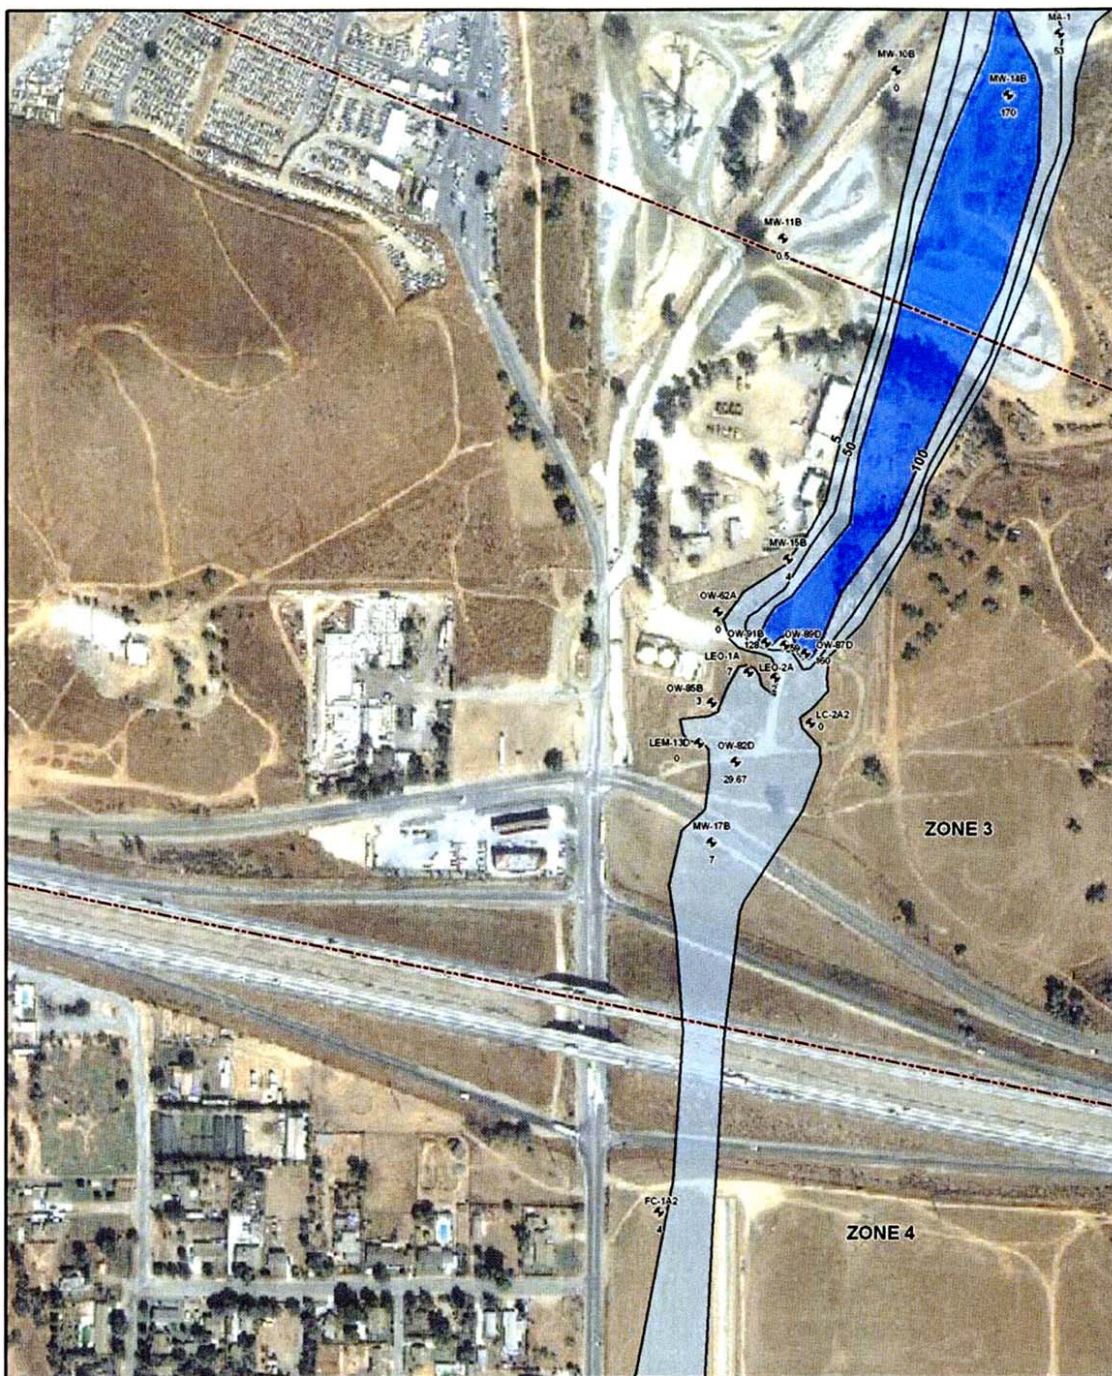
**FIGURE 4**  
**TCE DISTRIBUTION, ZONE 1**  
STRINGFELLOW FIVE-YEAR REVIEW REPORT  
GLEN AVON, CA

Several indicator contaminants are currently used as the key parameters to monitor the groundwater contamination at the site. These contaminants include TCE, total VOCs, perchlorate, para-chlorobenzene sulfonic acid (p-CBSA), sulfate, and select metals. TCE contamination distribution maps are provided in Figures 4, 5, 6, and 7 (for Zones 1, 2, 3, and 4, respectively). As presented in the figures, TCE concentrations are greatest in Zone 1, and decrease with distance from Zone 1. Perchlorate has been detected as far south as the Santa Ana River at the southern end of Zone 4 (Figure 8).

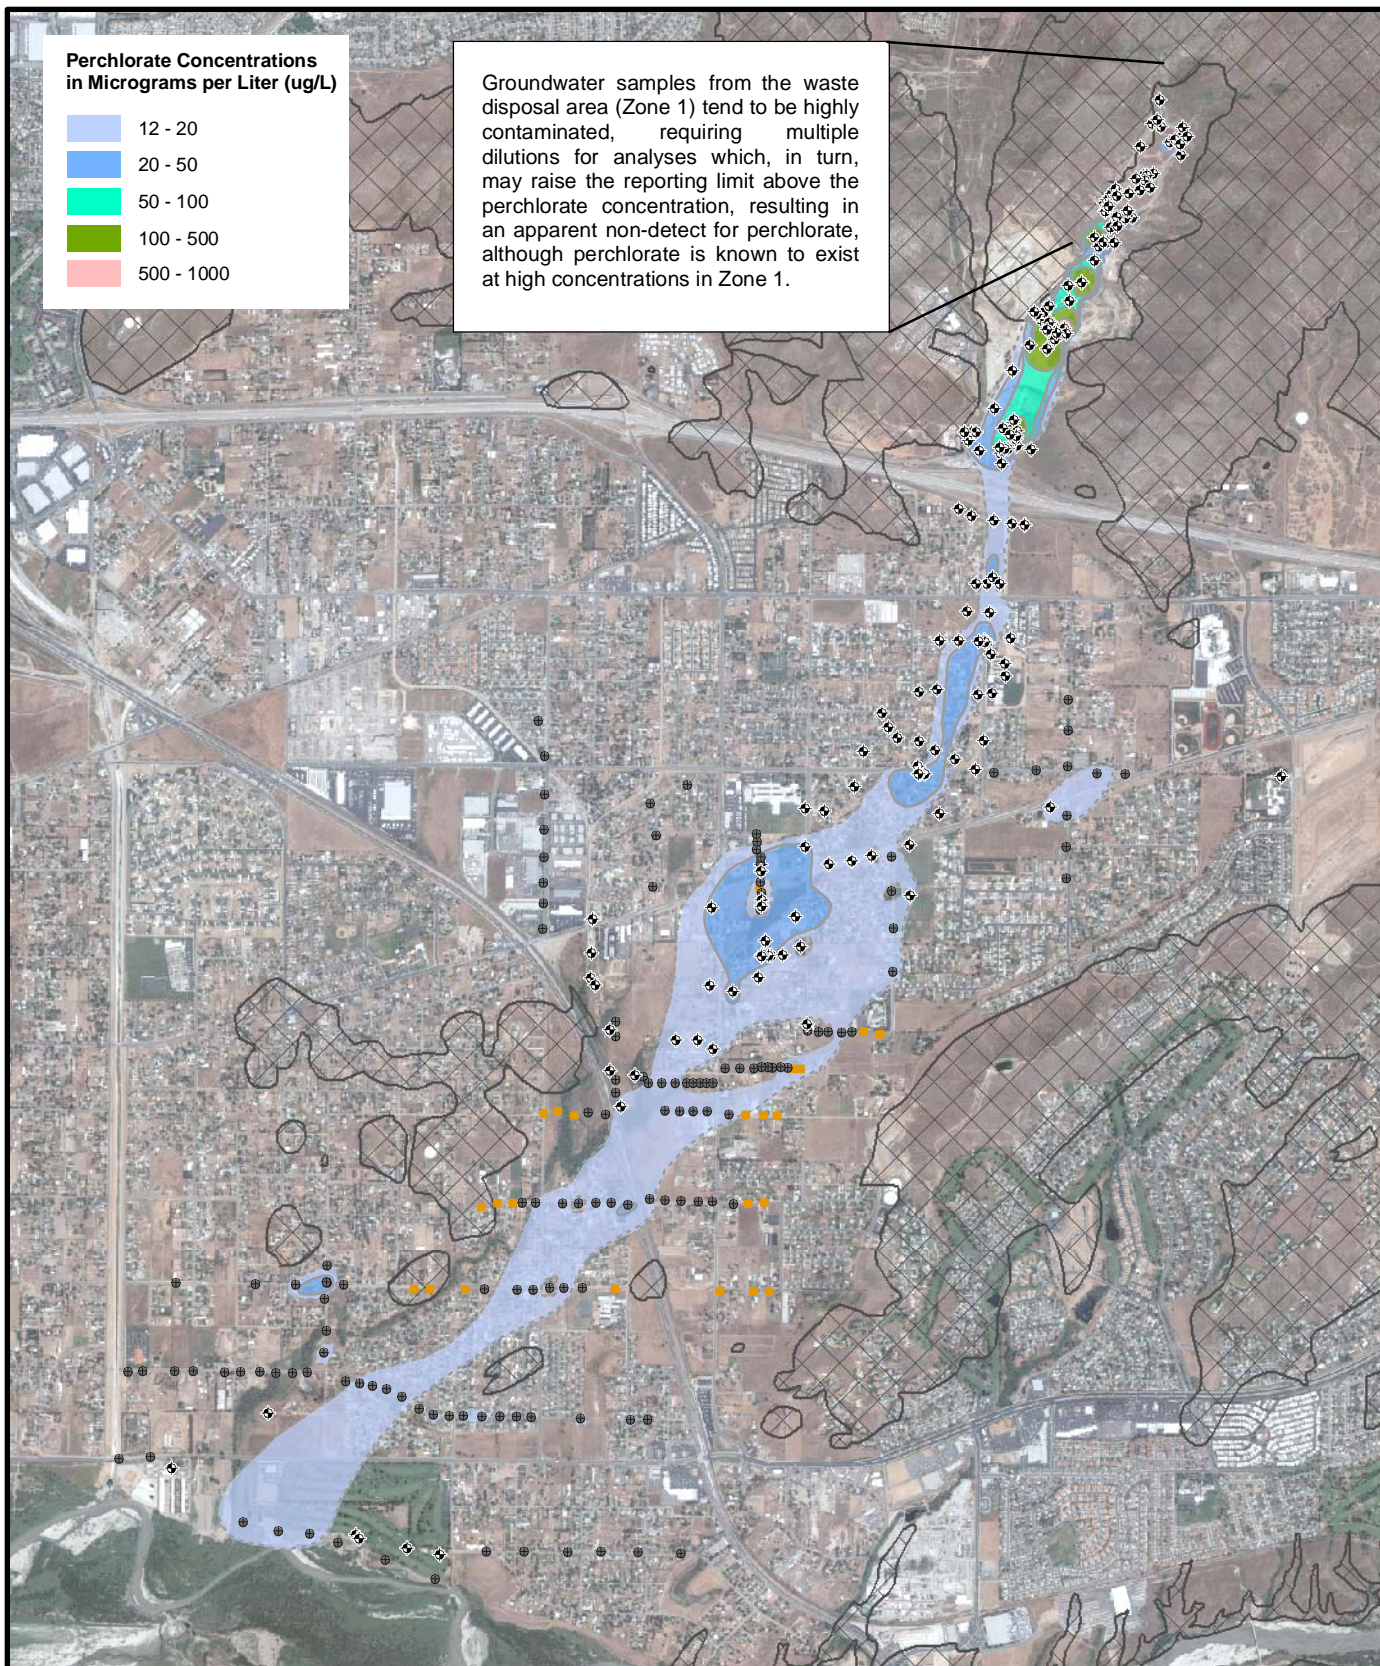
**FIGURE 8  
PERCHLORATE DISTRIBUTION  
IN GROUNDWATER IN ALLUVIUM,  
MARCH 2006**  
STRINGFELLOW FIVE-YEAR REVIEW REPORT  
GLEN AVON, CA

Groundwater samples from the waste disposal area (Zone 1) tend to be highly contaminated, requiring multiple dilutions for analyses which, in turn, may raise the reporting limit above the perchlorate concentration, resulting in an apparent non-detect for perchlorate, although perchlorate is known to exist at high concentrations in Zone 1.
